Gel Bleed and Rupture of Silicone Breast Implants Investigated by Light-, Electron Microscopy and Energy Dispersive X-ray Analysis of Internal Organs and Nervous Tissue

R.M. Kappel¹, L.L. Boer² and H. Dijkman^{2*}

²Department of Pathology, Radboud University Nijmegen Medical Centre, Nijmegen, the Netherlands

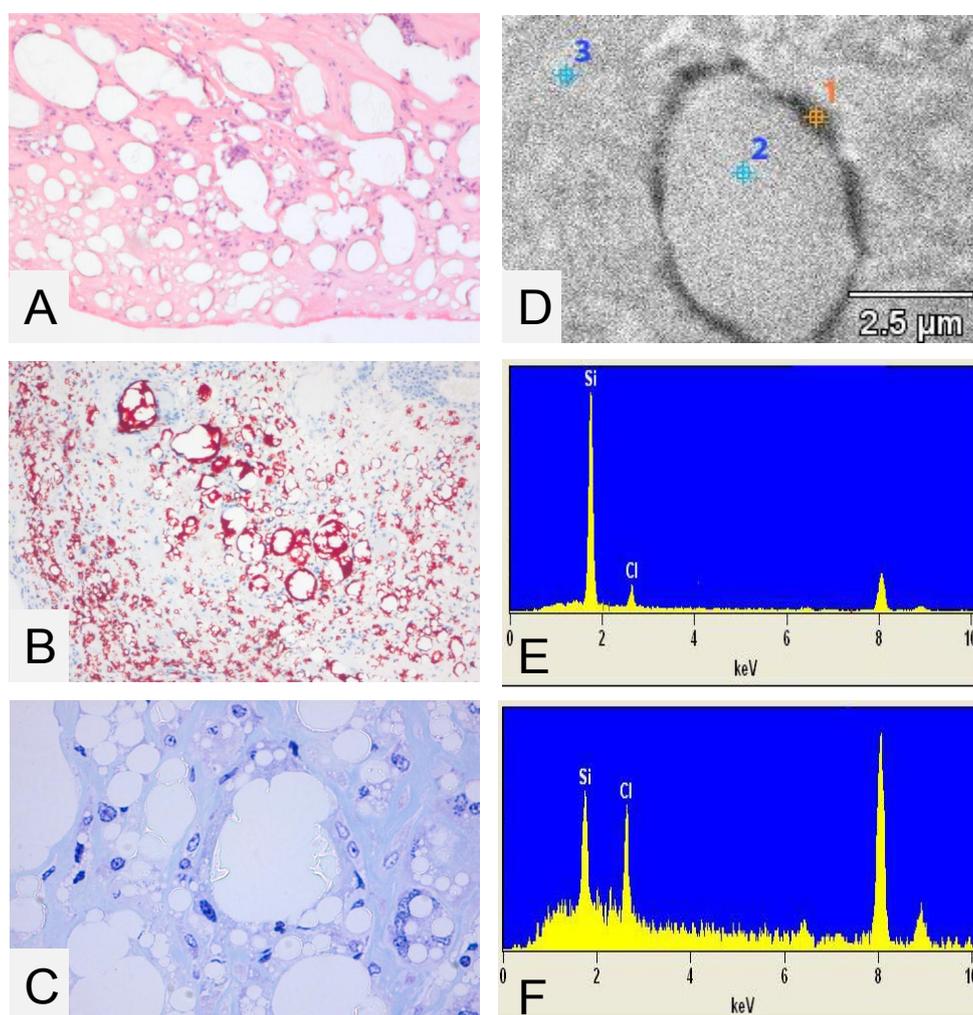
Figure 1: (A) A histological 4 µm paraffin cut of the capsule surrounding the silicone implants from patient 2 with bleeding and complete rupture of the implant. As can be seen there are numerous vacuoles which are, as viewed by a higher magnification, filled with threadlike structures of translucent amorphous refractile non-polarizing material suggestive of silicone deposition (HE staining); (B) A histological 4 µm paraffin cut from the capsule surrounding the silicone implant from patient 2 stained with the MORO to demonstrate if the translucent amorphous thread like structures are stained. As can be seen strong positive stained material is present, particularly located perivacuolar; (C) A higher magnification of the semi thin toluidine blue stained cut from the capsule surrounding the silicone implants of patient 2. As can be seen clearly there is a vacuole partially filled with threadlike structures of translucent material. Also here the vacuoles are not completely filled with the material, suggesting there is material lost in the processing steps. The embedding of the tissue in epon makes it inappropriate to visualize (stain) the silicone with the MORO staining. EDX analysis is performed to conclude if high concentrations of silicone are measurable; (D-F) EDX spectra and EDX analysis of a non contrasted 200 nm EPON section from the capsule surrounding the implant from patient 2. Top right image shows three measuring points. Point 1 is on the electron dense perivacuolar material, point 2 and 3 are in and around the vacuole; As can be seen in spectra 1 there is a high peak of elemental silicon at 1.74 KeV (E); In measuring points 2 and 3 there are considerable less amounts of elemental silicon found and stay under 500 silicon net counts (F). With this in mind we have set a standard: net counts lower than 500 are negligible and counts over 1000 are of silicon stacking and of pathological interest. As can be seen in measure point 1 there are 6626 Si- counts and thus suggestive for silicone stacking. Chlorine peaks found at approximately 2.6 KeV are originating from the EPON, peaks at resp. 8 and 9 KeV are due to copper, used as material for the grid holder. Both peaks can be ignored. Picture E EDX on dense perivacuolar material (point 1). Si count 6.626. Inside the vacuole (point 2). Si count 302 and picture F EDX on the surrounding tissue (point 3). Si count 447. Original microscopic magnification A-B 50x, C 400x.

comprised of elemental silicon and titanium. The vacuoles (droplets) are comprised of elemental silicon. Thus we identified two variants of silicone containing material. These were also found in macrophages. Different stainings are the MORO silicone staining and Sudan Black/Normal ORO fat stains which have been performed on a silicone positive paraffin control, consisting of a peri prosthetic capsule. Also electron microscopical investigation and EDX analysis was done on this positive control. Questions about the specificity of the MORO staining for silicone in freeze and paraffin cuts could thereby be established (figure 1).

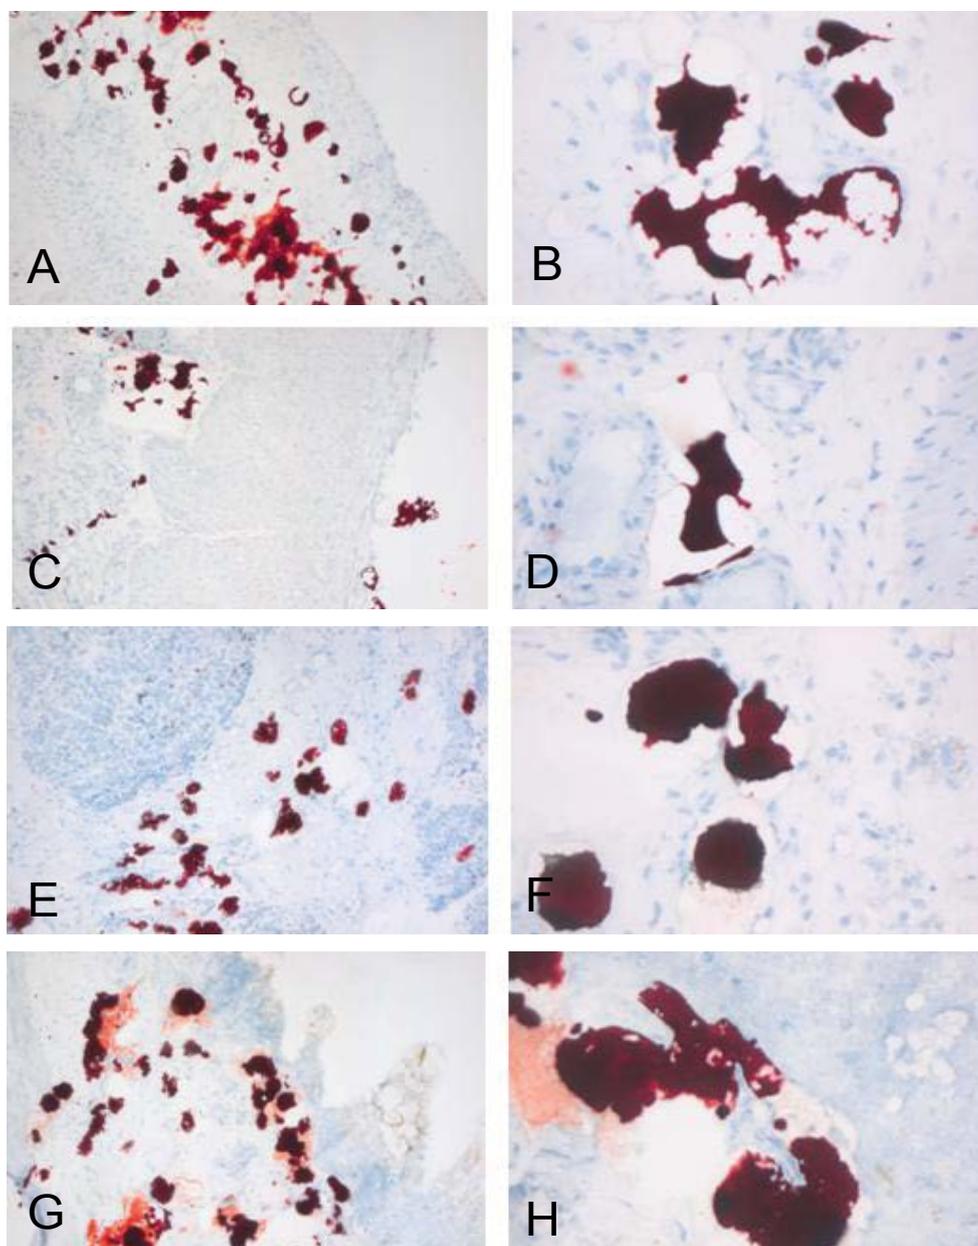
Figure 2: Pictures of the MORO stained 4 µm cryosections, are a representative selection from the positive stained tissues (table 1). Images clearly show strong positive stained material in; diaphragm (A-B); small intestine (C-D); pancreas (E-F) and colon (G-H), of patient 1. The positive material is often presented in vacuoles but often this material is not contained in the vacuoles and appears to be dragged or washed out. Original magnifications left 50x and right 200x.

The Modified Oil Red O (MORO) staining was initially performed on 4 µm freeze cuts from frozen material of our patient, acquired in body autopsy. This first staining was performed to check if any positive material is present and stainable. Results of this first MORO staining show large quantities of positive stained material in a large range of tissues. (Table 1 and Figure 2).

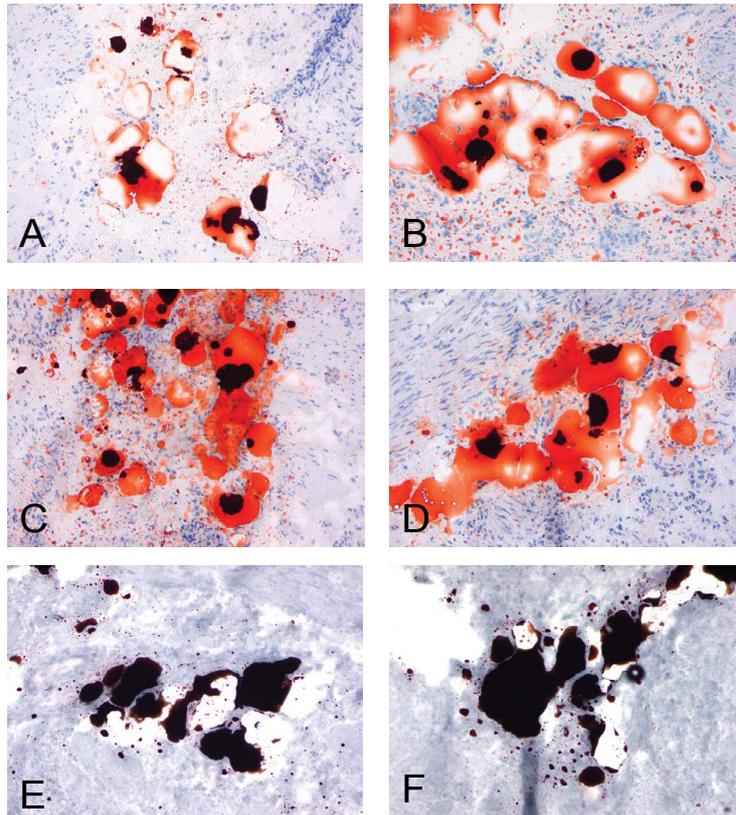
Figure 3: Pictures all show the same freeze cut of the frozen urinary bladder from patient 1 fixated with different fixatives previous to MORO staining. All left images are 4 μ m thick, all right images are 9 μ m thick. Panel A/B 15 minutes 4 % buffered formalin fixation. Panel C/D shows 15 minutes 2% glutaraldehyde fixation. Vacuoles are both in the 4 and 9 μ m cuts completely filled with positive stained material. Panel E/F shows 15 minutes 2% glutaraldehyde + 15 minutes 2% osmium tetroxide fixation. As can be seen in all panels there is a significant amount of positive material present. Original magnification: all 100x.

To ensure that the frozen material from patient 1 also contains the silicone after treatment with different fixatives we performed MORO staining on different samples. As can be seen in all panels there is a significant amount of positive material present (Figure 3).

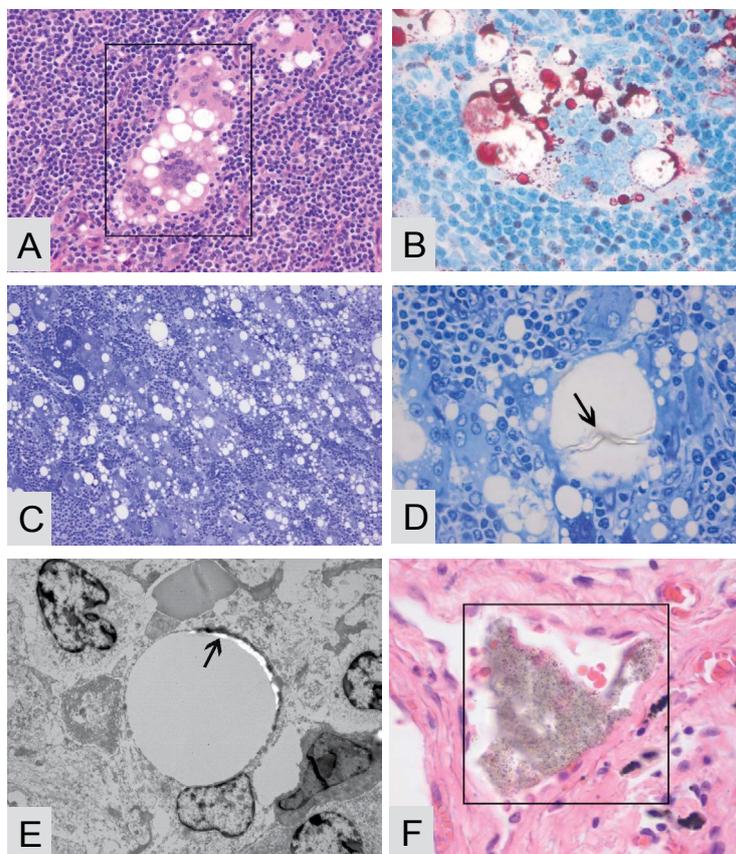
Figure 4: Multiple lymph nodes of patient 1 were filled with large quantities of multinucleated giant histiocytes in presence of possible exogenous material, suggestive of silicone A-E. (A) A 4 μ m paraffin cut stained with Hematoxylin and Eosin in presence with a giant histiocyte and cytoplasmic vacuoles filled with, when viewed with higher magnification, translucent amorphous material; (B) A 4 μ m paraffin cut stained with the MORO, positive stained material is present inside the giant histiocytes; (C) A 1 μ m toluidin blue stain where multiple giant histiocytes are seen in presence of multiple vacuoles; (D) A higher magnification of the toluidin blue stain where threadlike translucent material is present inside the vacuoles; (E) A TEM micrographs of a vacuole with dens perivacuolar material, on this dens material EDX analysis is performed, see details [Figure 5 A-B](#). Often material is clearly located inside a blood vessel, this event can be found throughout all tissues (F). Original microscopic magnification; A/B and D/F, 400x, figure C, 200x and figure E 5000x

Also different lymph nodes were excised for histological examination and showed extensive foreign body reaction in the presence of many epithelioid multinucleated giant histiocytes and the presence of translucent material, suggestive for silicone. MORO positive stained material is located inside vacuoles and histiocytes (Figure 4). Samples are cut approximately 100 and 200 nm thick for assessment in TEM and analysis by EDX. EDX analysis is performed on this lymph node material to see if large amounts of elemental silicon is measurable. (Figure 5).

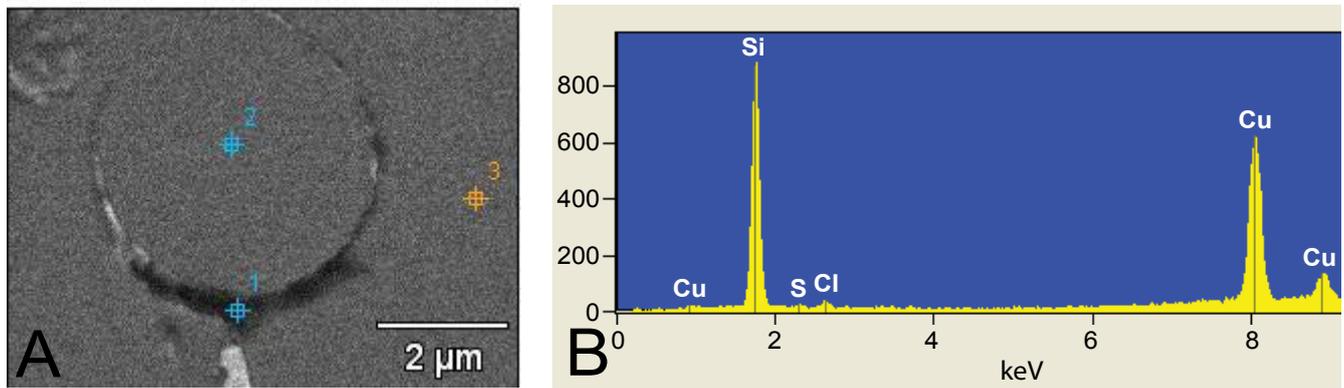
Figure 5: TEM micrograph of the EDX measuring points performed on the lymph nodes of patient 1. Point 1 is on the dens perivacuolar material. Point 2 is inside the vacuole and point 3 is on the surrounding tissue (A); EDX analysis of patient 1 lymph nodes from the subcutaneous swelling in the left armpit. Point 1 (spectra 1) = 10759 Si-counts (B). As can be seen in measuring point 1 there is a large peak of elemental silicon found which corresponds with the electron dens perivacuolar material.

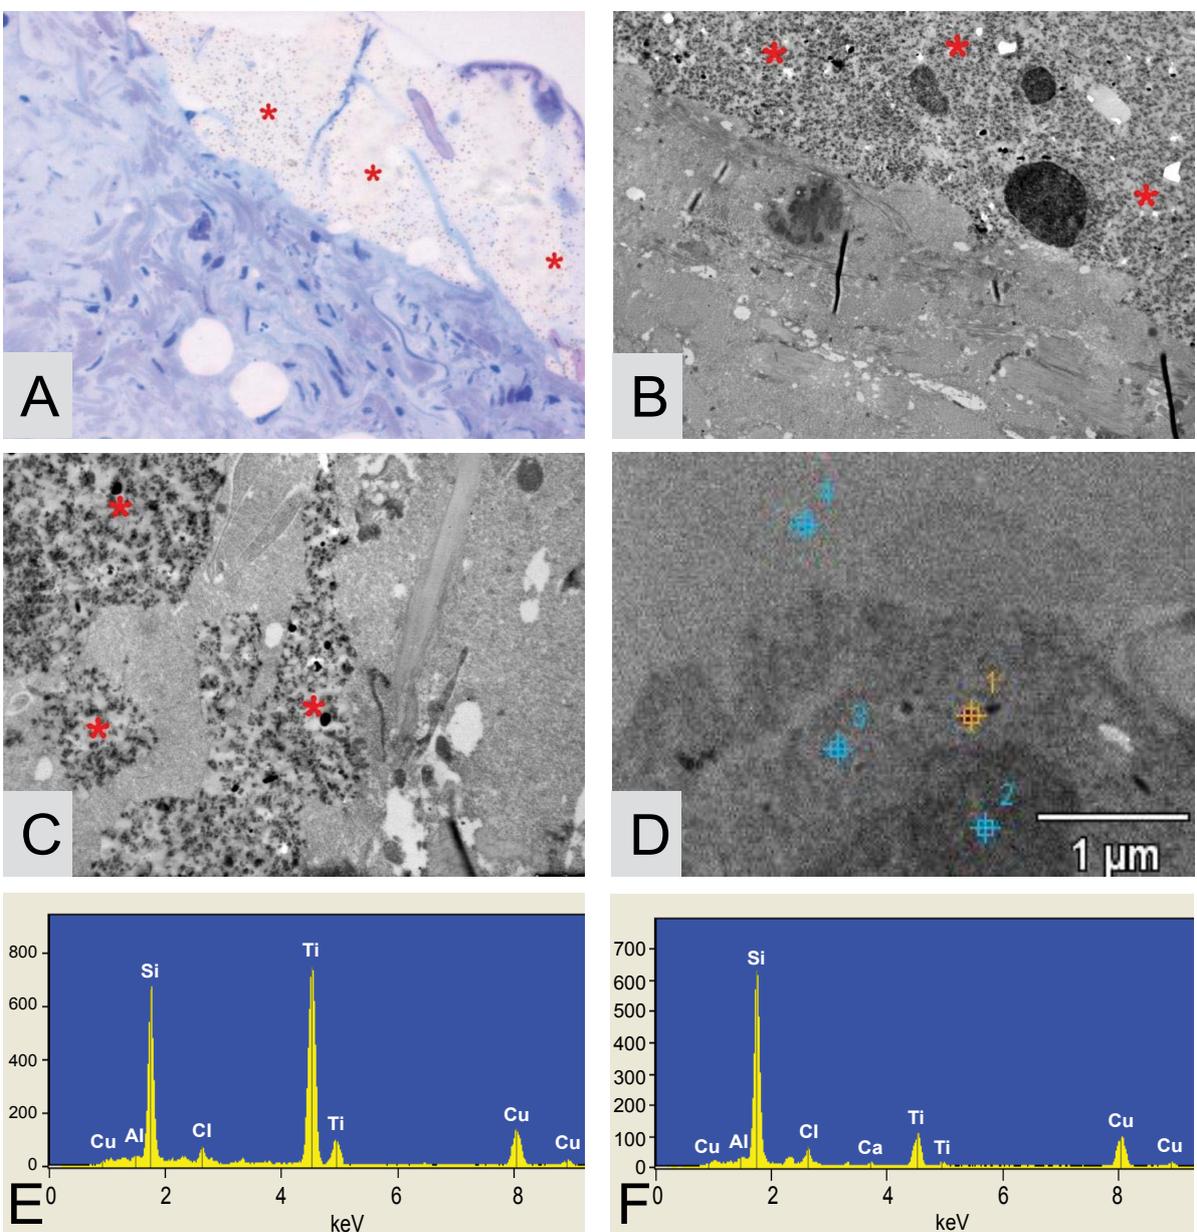
Figure 6: Figures show the plaque like structures * found in the thyroid of patient 1. (A) The toluidin blue stained epon section, the plaque is located alongside the tissue, suggesting that it has no connection with the tissue; (B) A TEM micrograph where it is nicely demonstrated that the plaque like structure is situated around collagen; (C) A higher magnification of a TEM micrograph where it is nicely demonstrated that the plaques are completely surrounded by thyroid tissue. Dens small particles inside the plaque are clearly visible. EDX analysis is performed on these structures; (D) The TEM micrograph of the EDX measuring points performed on the thyroid of patient 1; (E) Depicted EDX on a dens particle found inside the plaque (spectra 1) = 7200 Si-counts/11652 Ti-counts; (F) EDX on the plaque itself (spectra 2) = 7252 Si-counts/1579 Ti-counts and point 3 is on the surrounding tissue (spectra 3) = 545 Si-counts (not shown). Original microscopic magnifications figure A/B and C; resp. 400x, 3K and 7.5K.

EDX analysis reveals the true nature of the plaque like structures found in the toluidin blue stain, elemental silicon and titanium were found in all the plaque like structures. The found component of elemental titanium represents the dens particles located inside the plaques. Also loose droplets of elemental silicon were found, situated partially in vacuoles, for instance in the thyroid gland, figure 6.

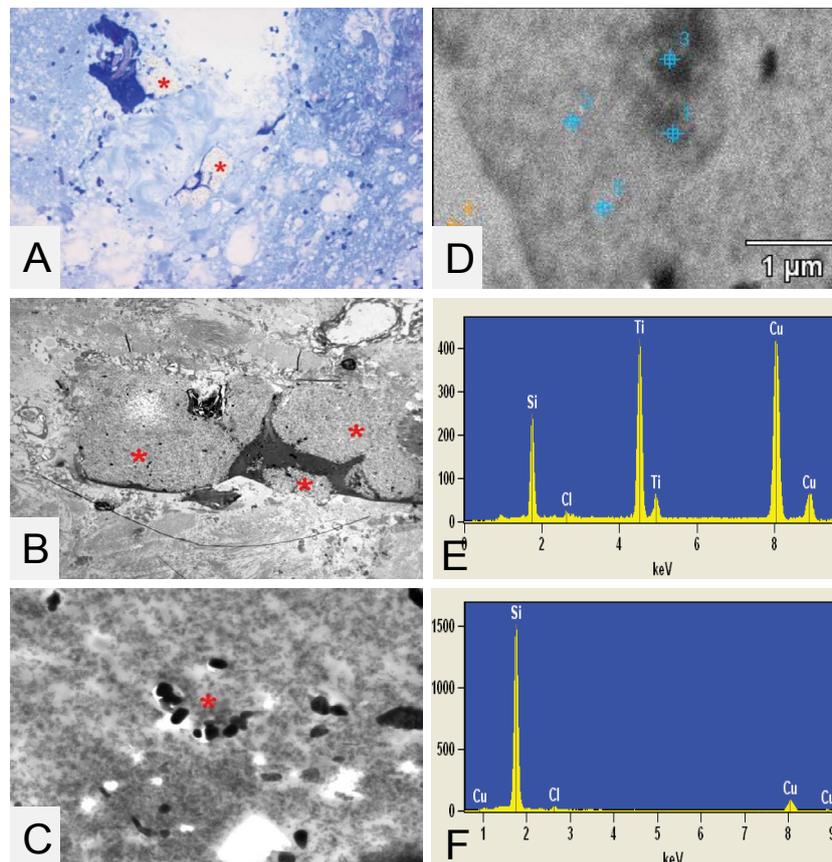
Figure 7. (A,B and C) The plaque like structures * found in the high cervical spinal cord of patient 1. (A) The toluidin blue stained eponsection, the plaque is located inside the surrounding spinal cord tissue; (B) A TEM micrograph where it is nicely demonstrated that the plaque like structure is situated around collagen and in close proximity of nerve tissue; (C) A higher magnification of a TEM micrograph where small particles inside the plaque are clearly visible around the asterisk. EDX analysis is performed on these structures and detects Si and Ti, (E); (D) The TEM micrograph of the EDX measuring points performed on the high cervical spinal cord of patient 1 and demonstrates inside the plaque (spectra 1) = 16854 Si-counts (F). Original microscopic magnifications figure A/B and C; resp. 200 x, 1.5K and 12K.

The plaque like structures found in the spinal cord of patient 1 are located inside the surrounding spinal cord tissue. The TEM micrographs demonstrate the plaque like structure and a higher magnification of a TEM micrograph show small particles inside the plaque, clearly visible around the asterisk. EDX analysis is performed

on these structures (Figure 7 and Figure 8). Measurements are done using EDX-spot-analysis, measuring a surface in the range of 0.1-0.15 square microns. A summary of the EDX-measured Si counts is given in table 2.

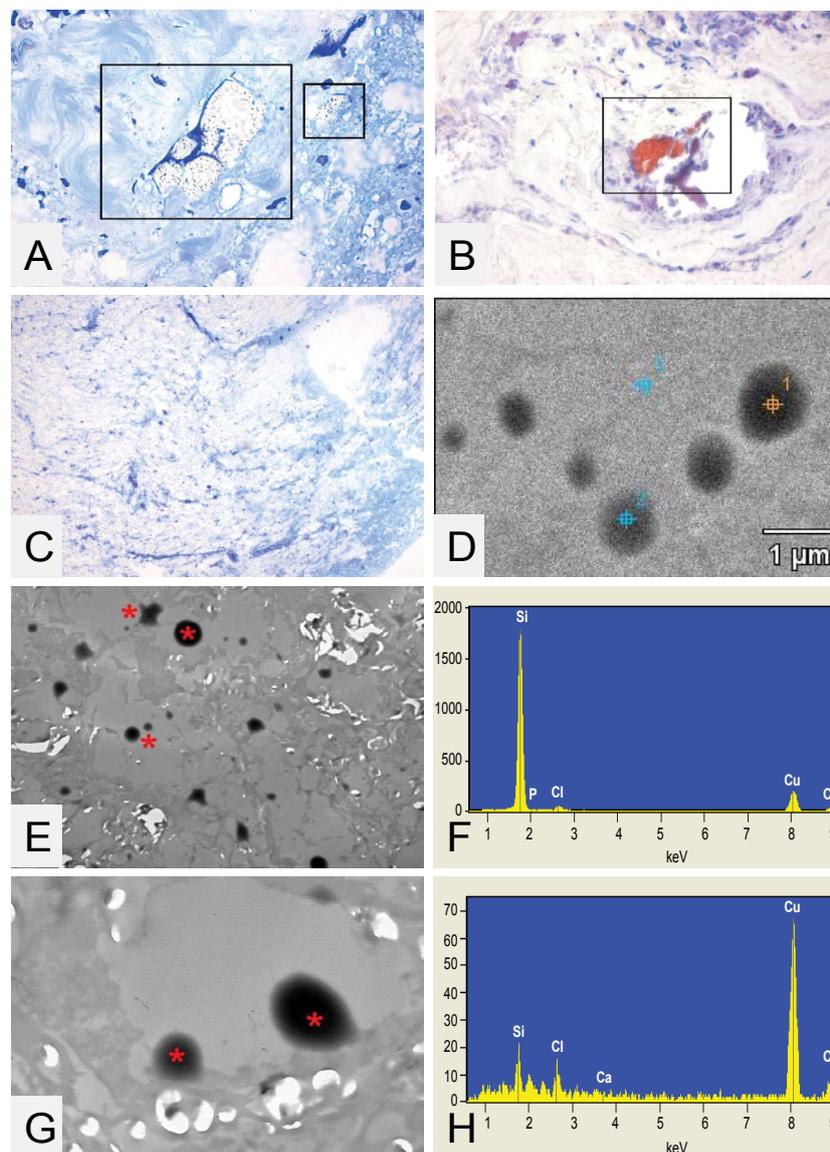
Figure 8: (A) Toluidine blue of the spinal cord high cervical, clearly visible is a structure located around collagen, same structures often are positive with MORO staining, reddish plaque is visible (B); (C, D and E) The droplets * found in the thoracic spinal cord of patient 1; (C) The toluidin blue stained epon section, no visible droplets are detectable; (E) A TEM micrograph where it is nicely demonstrated that there are actually droplets present located inside vacuoles which appear to be partially washed out; (G) A higher magnification of a TEM micrograph where it is clearly seen that the droplets actually are located inside a vacuole and are part of the tissue. EDX analysis is performed on these droplets, figure D shows a TEM micrograph of the EDX measuring points performed on the thoracic spinal cord of patient 1; (F) Demonstrates EDX analysis Point 1 on a droplet found inside vacuolated spaces (spectra 1) = 22211 Si-counts. Point 3 is on the surrounding tissue (spectra 3) = 195 Si-counts (H). Original microscopic magnifications figure A and B 400x, resp. 200x, C-E and G; resp. 50 x, 2.5K and 10K.
